# BATS & HERITAGE STRUCTURES

Protecting bats during management, restoration  
and maintenance works at heritage sites

By Niamh Roche and Tina Aughney

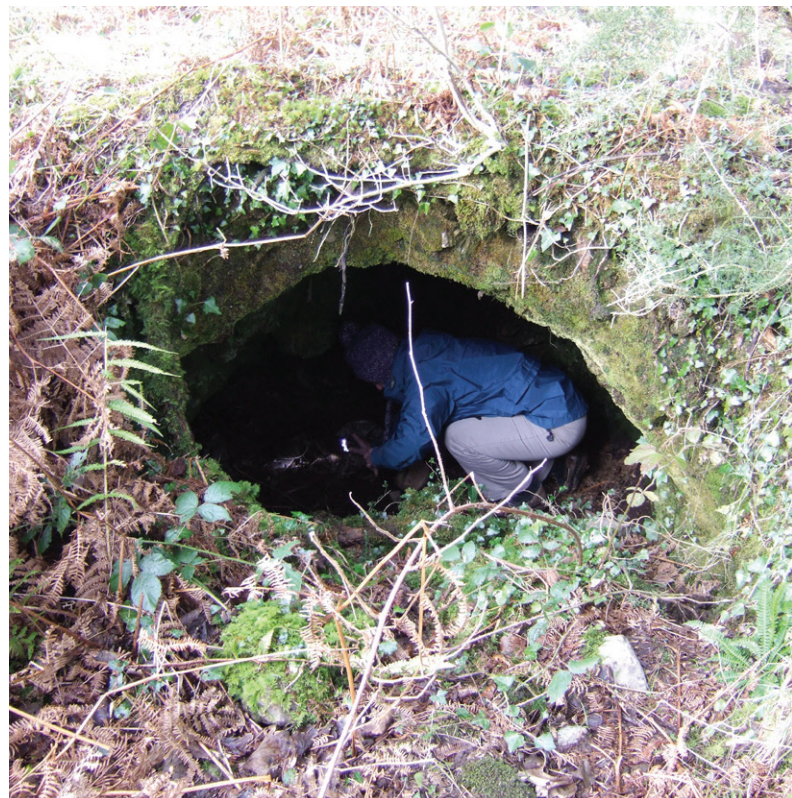
**Checking for bat droppings at a souterrain in Kerry**  
© Niamh Roche

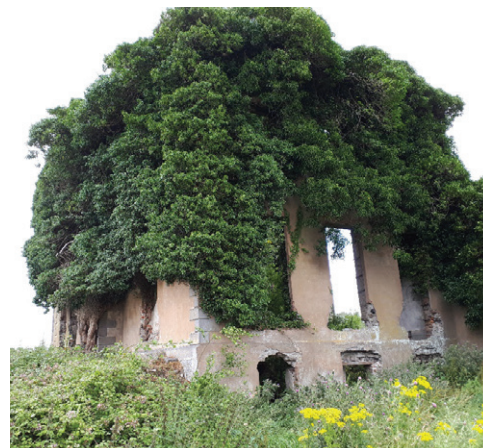
This heritage building may require a dusk and dawn survey to determine if bats are present, it is also in an advanced state of dereliction and may be structurally unsound in places © Niamh Roche

Sometimes the full extent of a building might not be accessible - for example if the roof has deteriorated, if it is structurally unsound or if there is no access point via an attic hatch. In this case it would be important to carry out a survey during the active season to see if bats emerge from it at dusk or return to it at dawn.

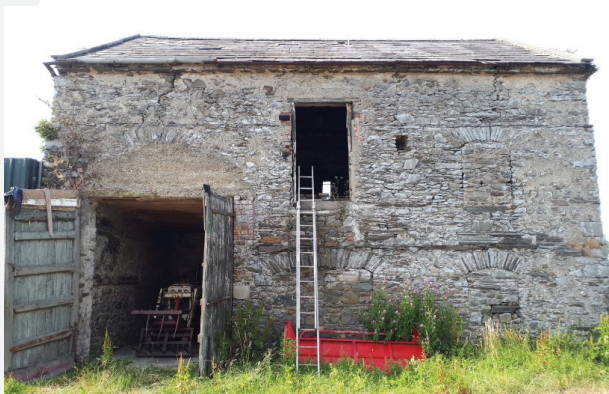
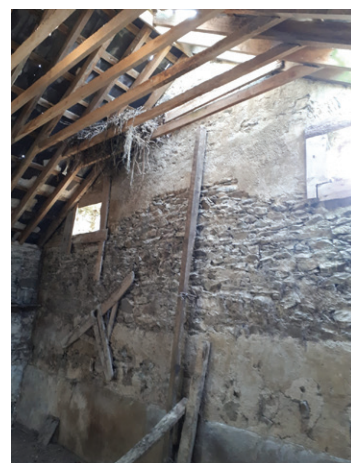
Building prior to reroofing – farm machinery stored at ground floor level © Niamh Roche

The owner successfully applied for grant assistance under the GLAS Traditional Farm Buildings Scheme (administered by the Heritage Council) to reroof it, and under the terms of the grant award, commissioned an ecologist to carry out a survey of the building. The ecologist explained the legislation protecting bats to the site owner prior to carrying out the survey and explained that a derogation licence would need to be applied-for if bats were found as the planned works were likely to result in disturbance to the roost.

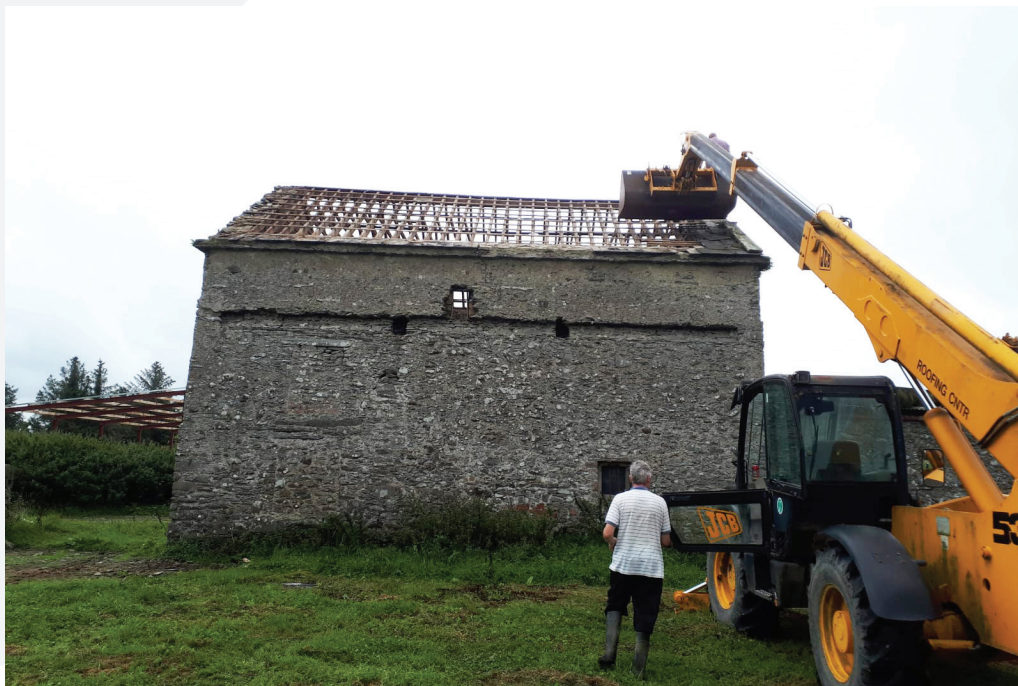
Slates were removed one by one on a phased basis, in September © Niamh Roche

The re-roofing took place in September. A tool box talk was given on site by the ecologist prior to commencement. Slates were carefully removed one by one by the roofer. The slate removal was carried out on a phased basis over a number of days. An additional benefit of removing the slates one by one was that many remained intact and were salvaged to re-use on the building.

The ecologist was on hand to assess any bats that may be found as the slates were removed. In the event, two bats were disturbed when slates were removed, but both flew immediately away unharmed towards nearby trees. The reroofing took place afterwards using salvaged natural slate. No roofing felt was used.

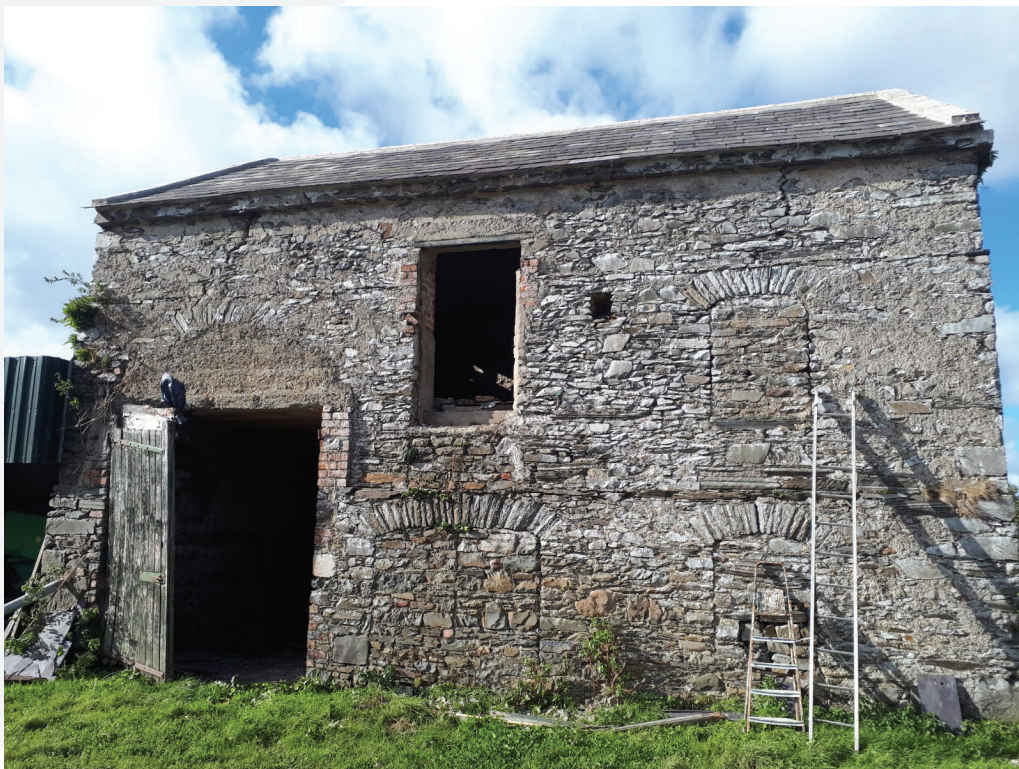
**The building newly re-roofed in October** © Niamh Roche

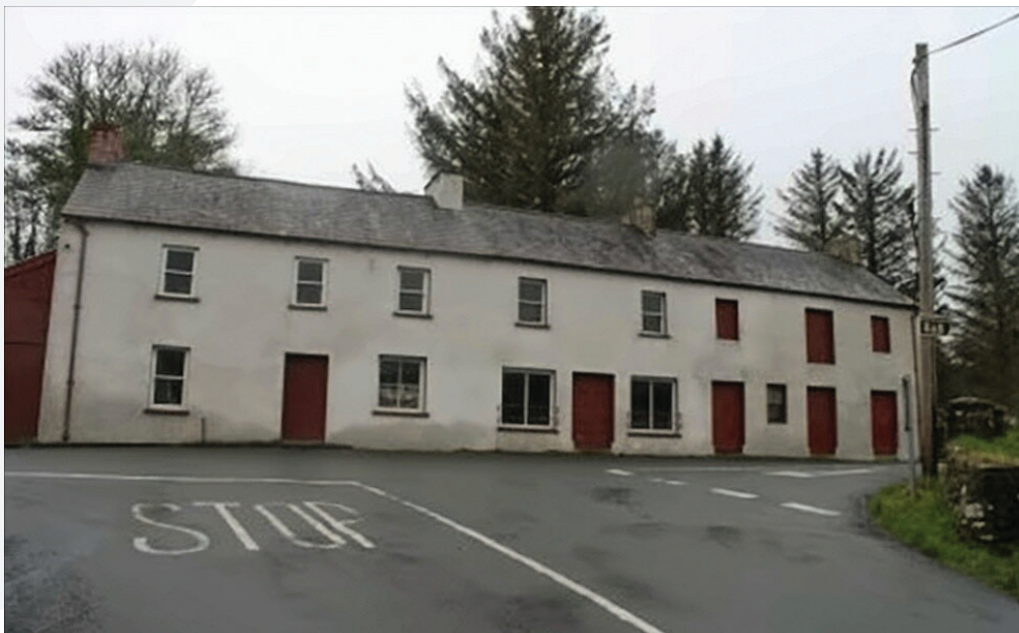
Front façade of Gallaghers, Newmills © Caroline Shiel

A bat ecologist was contacted by the OPW because the eastern section of the roof of Gallagher's House was in need of re-roofing. Many of the slates had lifted and some had slipped out of position. Roof timbers in the building were also in a state of decay from woodworm and wet rot and therefore required replacement or treatment. In addition, support beams had to be inserted at first floor level in the dwelling house.

An initial site visit in March revealed the presence of at least one bat roost. This was followed up by a summer survey at dusk and dawn using bat detectors. A maternity roost of 22 Leisler's bats *Nyctalus leisleri* and roost of c.30 Natterer's bats *Myotis nattereri* bats were found in the loft space above stables. Re-roofing was planned for the eastern section of the dwelling house, while the bats were found in the central and western sections of the roof. The ecologist concluded that if re-roofing of the building could be conducted in a sensitive manner and under derogation licence that it would be possible to retain the two roosting sites.

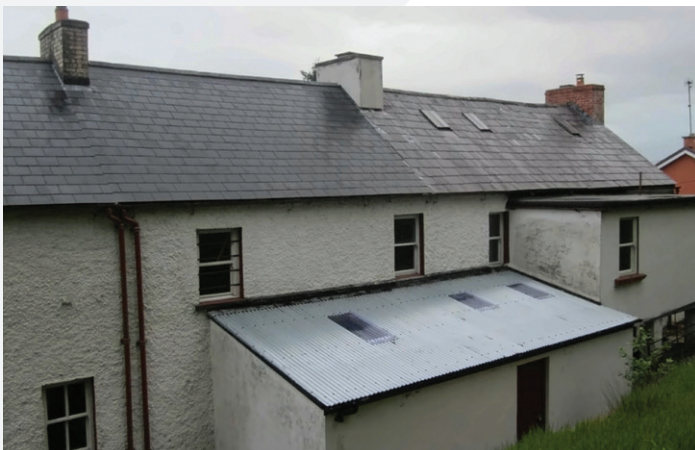
Rear of building showing section of roof (to right) in poor condition. The remainder of the roof is in good condition  
© Caroline Shiel

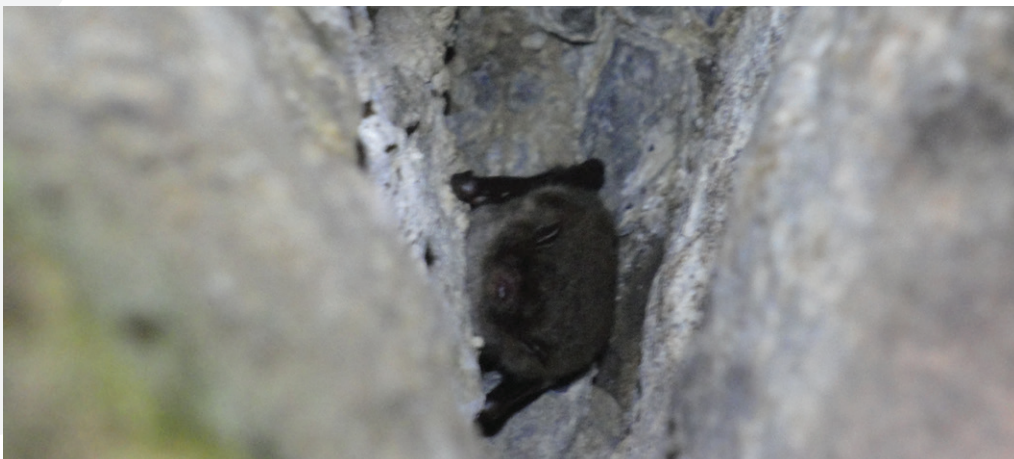
Daubenton's bat in crevice © Tina Aughney

Each archway was inspected during the daytime and crevices that were used by bats and/or were suitable for roosting, were marked. Discussions with on-site engineers identified the extent of works required to ensure the structural integrity of the bridge for the future. Five of the six arches were used by individual bats (Daubenton's bat, Natterer's bat and brown long-eared bat) while one arch was used by a cluster of bats (Daubenton's bat). Therefore, works were planned for the five less significant arches, while it was decided that no works would be undertaken on the archway with clusters of bats.

Phase 1 involved “closing” the arches to allow re-pointing of crevices and this was undertaken during the spring. They were closed using debris/wind break netting after a dusk survey was completed to ensure that no bats were present. A small number of crevices in each arch were also marked to be retained (i.e. not re-pointed to ensure that there were roosting crevices available post-works). The individual “curtains” for the arches could be opened during the day to allow re-pointing to be undertaken but it was essential to close the arches at night-time to ensure bats did not return to roost. Alternative roosting in the form of bat boxes and bat tubes were provided on an adjacent bridge.

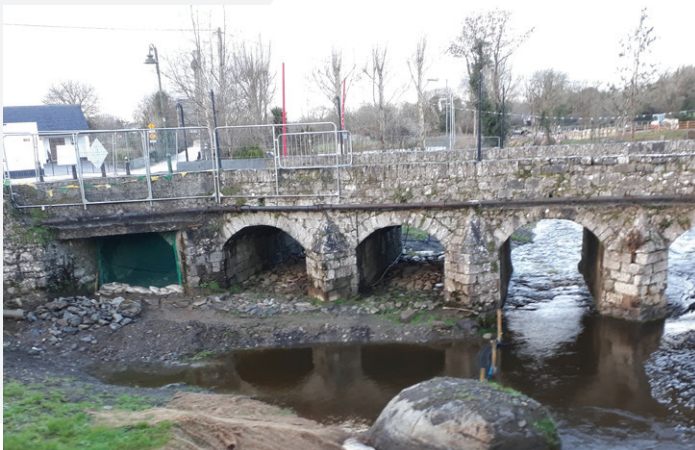
**Individual arches of bridge with one of the dry arches closed**  
© Tina Aughney

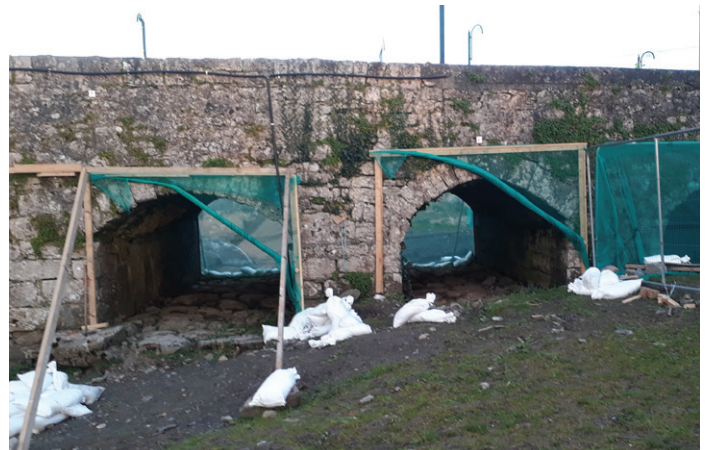
**Open curtains to allow work to be undertaken during the daytime**  
© Tina Aughney

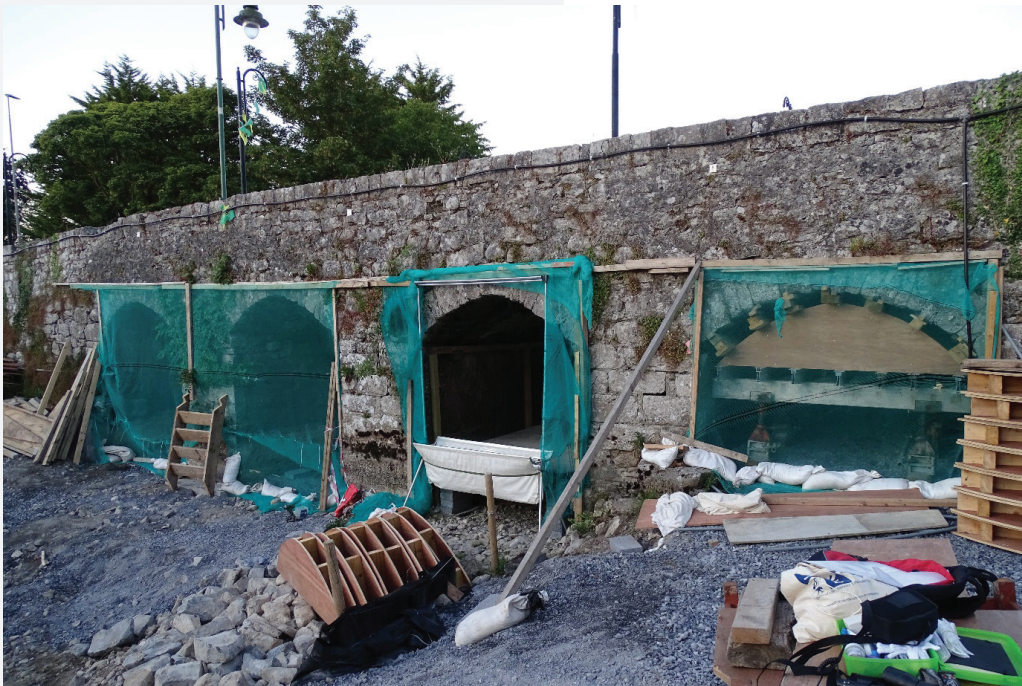
Harp trap in place during survey of "bat" arch © Tina Aughney

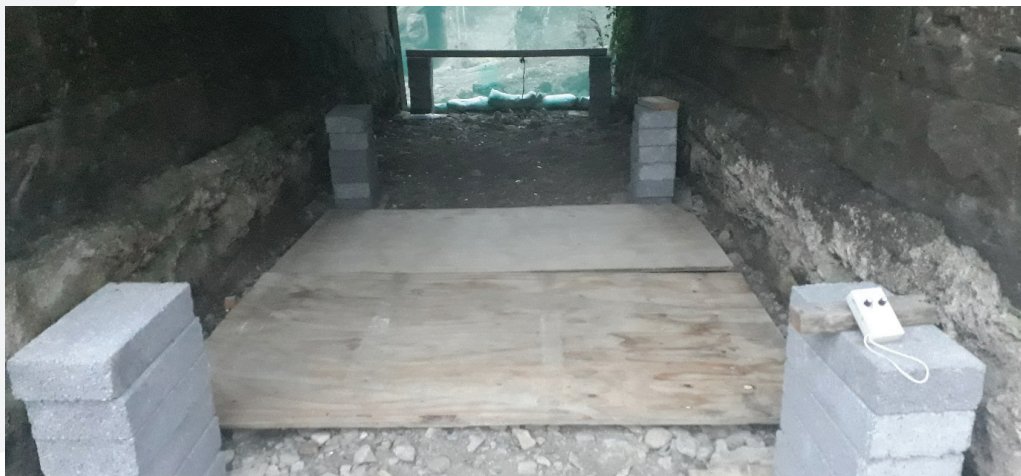
Plywood sheets below the main roosting site to determine if bats are present during Phase 2 works © Tina Aughney

Phase 2 of the works required re-surfacing of the upper surface of the bridge. As this was across the whole bridge, the whole bridge needed to be temporarily bat-free to ensure that no bats were harmed during the works. This meant closing the main archway used by bats. The primary focus of the bat survey for this arch was to determine what type of bat roost was present. Depending on the time of the year, bat form different roosts. A maternity roost is the principal summer roost when females come together to give birth to a single baby. This is an important roost type due to its vulnerability. Therefore, as works were planned for mid-August to early September, a survey was undertaken in mid-August to determine what type of roost was in the main “bat” arch. A system using a harp trap was set up and 22 Daubenton’s bats were captured. Examination of these individuals determined that they were all male bats and the ecologist concluded that the bridge was not a vulnerable maternity roost.
