# Bats and Waterways

## *Guidance Notes for: Planners, engineers and developers*

*December 2010*

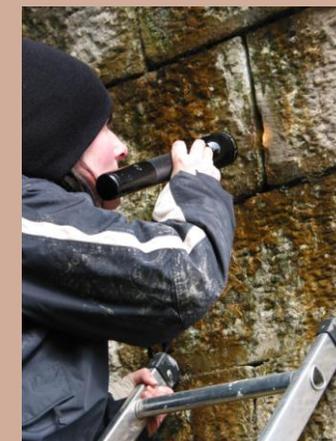
Crevices should be checked by using a high powered narrow beam torch light or an endoscope. A single soprano pipistrelle was found in this crevice.

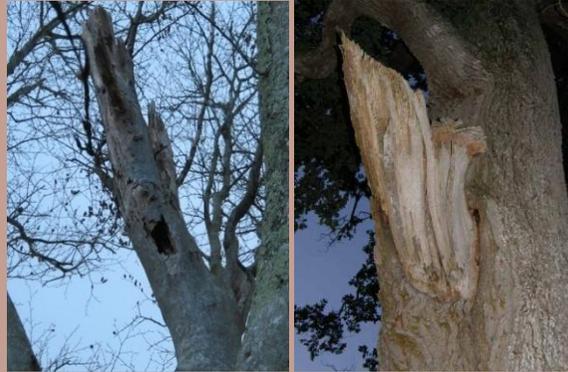
Above: Leisler's roosts in dead branches of beech and oak trees respectively (Photos: Tina Aughney & Brian Keeley)

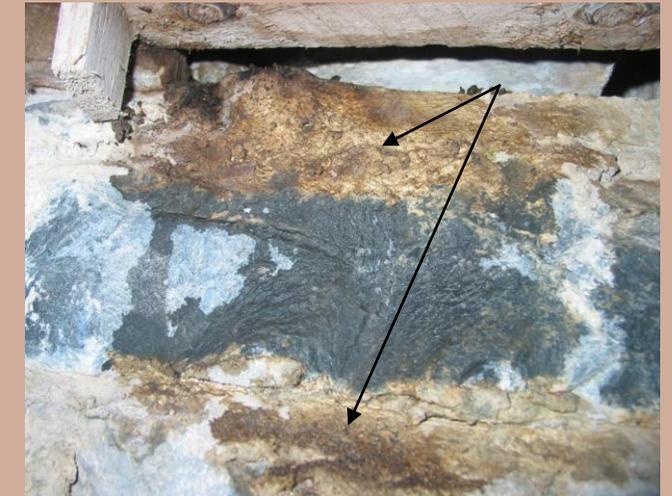
### **What does bat urine staining look like?**

This staining (indicated by arrows) is often present in a regularly used roosting site including stone crevices, trees, buildings etc.

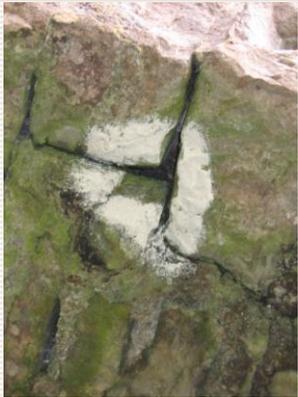
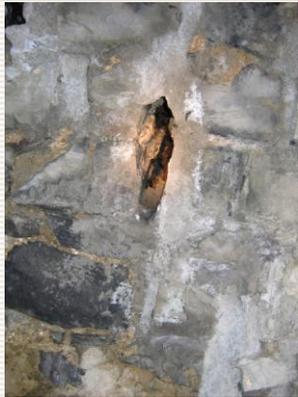
A selection of suitable crevices in stone structures should be retained (similar to those illustrated in the photographs to the left). These can be filled temporarily with timber or bubble wrap while all remaining crevices are re-pointed by hand. Once works are finished, remove temporary filling. Crevices should be at least 25cm deep, by 15cm long and 1-3cm wide.

Left: Example of crevices retained for bats in bridge works (Photos: Caroline Shiel)

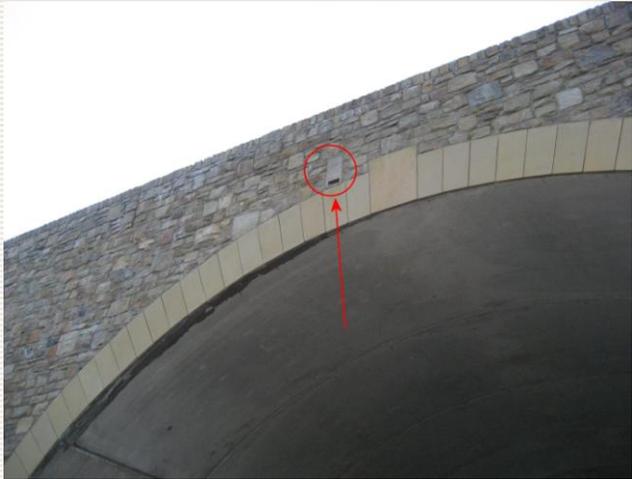
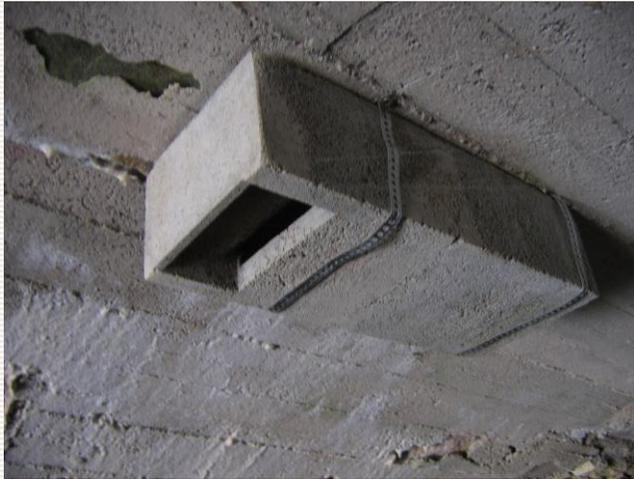
Above: Example of bat tubes incorporated into structures to create roosting sites for bats. Left: Bat tube was built into a new bridge. Right: Bat tube attached to the underside of a culvert. While 2 straps are shown here, it is recommended to use 3-4 straps to ensure long-term attachment. (Photos: Austin Hopkirk & Caroline Shiel)

Ready-made roosting boxes or tubes are available and can be easily inserted into structures to provide roosting sites for bats. Where natural crevices are not available or cannot be retained, a bat tube should be attached to the structure. Ensure that the bat tube is located at sufficient height (at least 1m) above winter flood waters to prevent residing bats from being drowned. Bat boxes are also available for attachment to mature trees or buildings

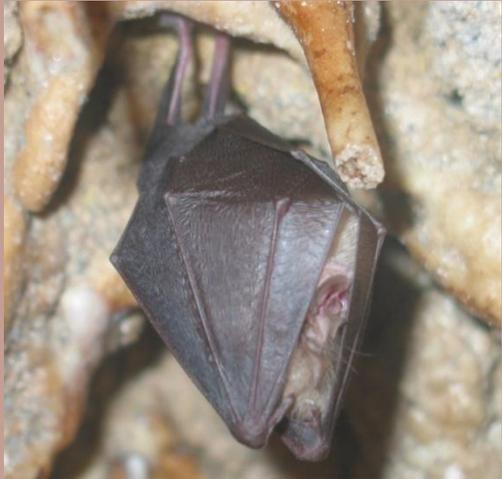
While this species is not a crevice dweller like all other Irish bat species and therefore unlikely to roost in bridge crevices, it is a species that is highly vulnerable to poor watercourse management. Uninterrupted treelines and hedgerows are essential for economic commuting by this species.

It is also likely to use stone structures adjacent to rivers as night roosts. Such roosts have an opening into the structure to allow unimpeded flight because this bat cannot land and crawl. It hangs freely from the roof. Buildings or structures used by this species should be retained with the appropriate openings: approximately 15cm by 30 cm in dimensions. This species has also been recorded hanging freely inside culverts and similar structures.

This species is only found in the western counties of Mayo, Galway, Clare, Limerick, Kerry and Cork. Therefore, works on watercourses in these counties must ensure that this species is considered. Please contact your local NPWS Conservation Ranger 1800 405 000.

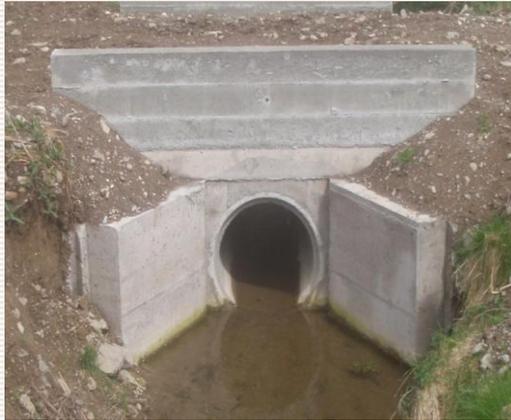
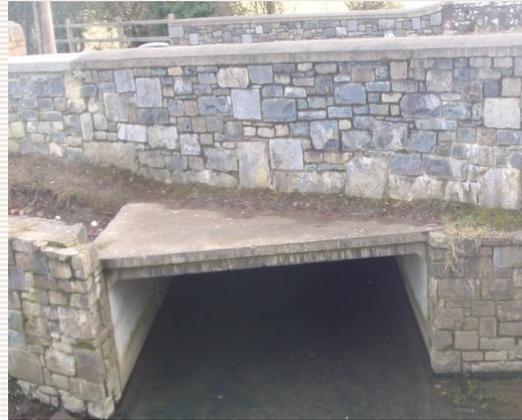
Examples of typical culverts that is **not suitable** for the erection of bat boxes or bat tubes. These structures are too low over the water level to erect safe roosting sites for bats as there is a potential of flooding.

*Bridges scheduled for maintenance need to be considered for the likelihood of bat roosting sites. Agricultural accommodation bridges and low profile culverts and bridges as shown above have a low bat potential due to the possibility of flooding.*

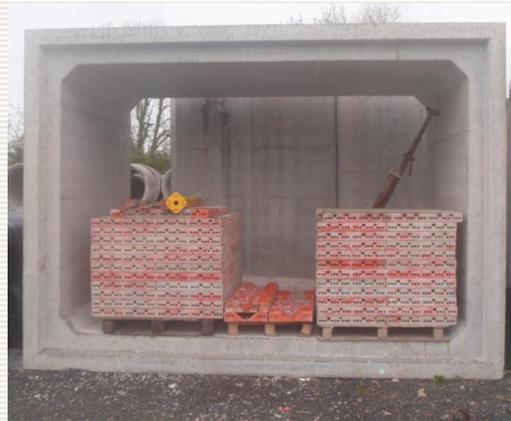
*Above left: Large box culverts – fit bat box or bat tube internally at the highest*

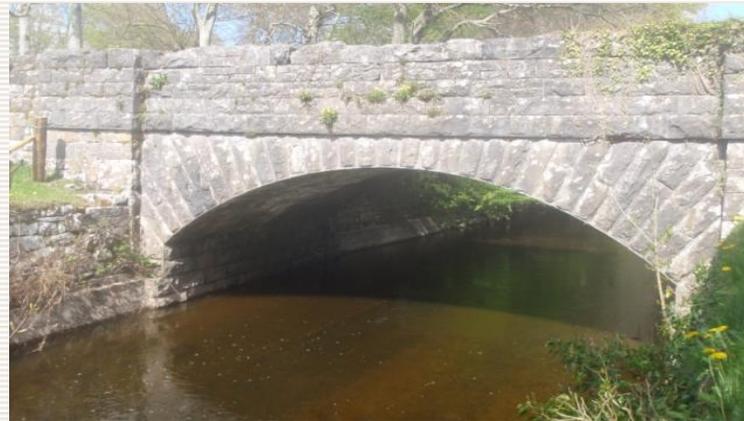
*Above right: Road Bridge – fit bat box to soffit or face of bridge*

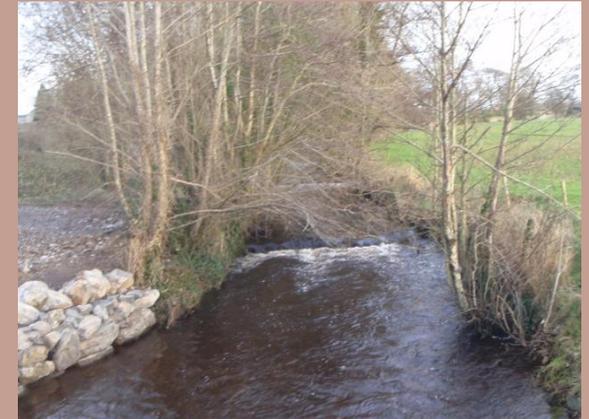
**ABOVE:** These trees are too immature to provide roosting sites for bat.

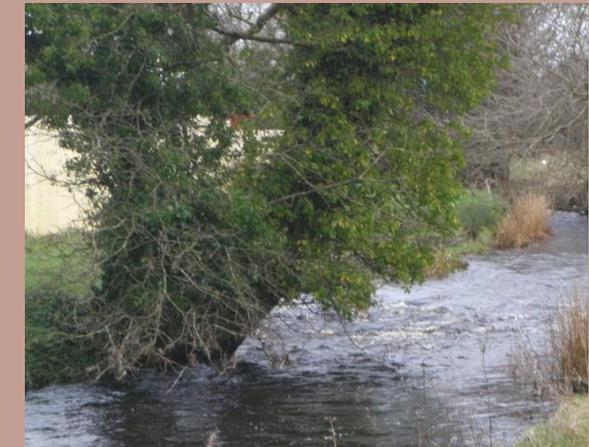
**ABOVE:** Trees with heavy ivy growth as show in photograph above can provide roosting sites for bats.

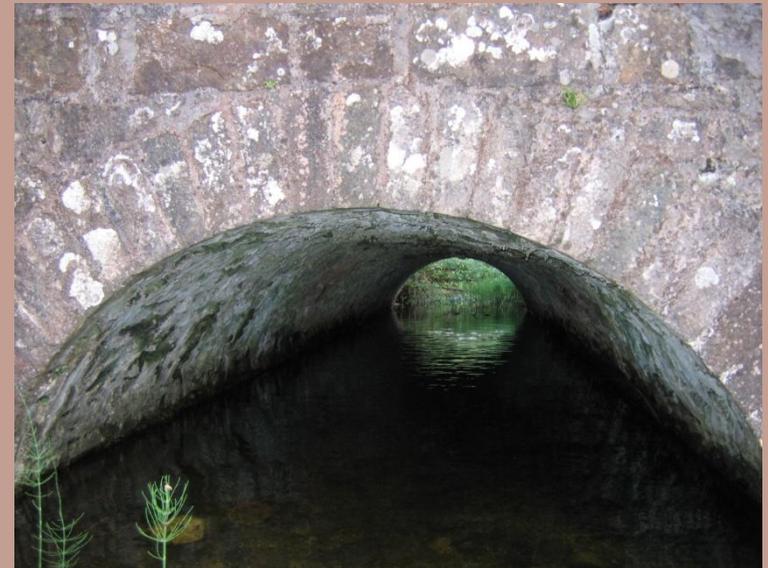
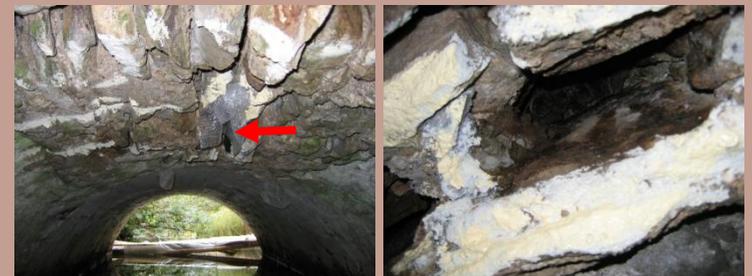
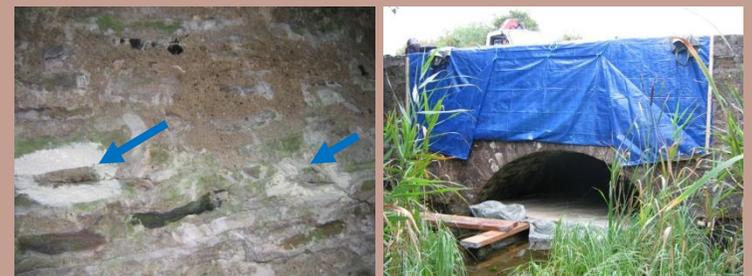
## Case Study: Carrick Bridge, Foxford, County Mayo

Photographs (From Top left to bottom right): Carrick Bridge; Location of maternity roost (red arrow); Close-up of void used by maternity colony; Crevices marked for retention (blue arrows); Tarpaulins in place on bridge.

**Results:** a maternity colony of approximately 20 Daubenton's bats *Myotis daubentonii* was located in a large structural fissure under the arch. In addition, a single Natterer's bat was recorded in a small crevice in the stonework under the arch. Bats were recorded roosting in 7 separate crevices. The damaged section which was housing the maternity colony was large with many interconnecting voids in the stonework.

**Mitigation Measures:** Retention of numerous small crevices (Crevices were clearly marked with white paint for retention) in the stonework and retention of part of the damaged section used by the maternity colony. Works were timed to take place during the month of September when the nursery colony had dispersed. For structural reasons it was not possible to retain all the voids being used by the maternity colony. It was noted that there was one main void in the section used by the maternity colony. It was decided to concentrate on retaining this void. The retention of each crevice/void was discussed with engineers on site to ensure that their retention would have no impact on the stability of the structure.

**Bat Measures Completed Prior to Works:** The day before the repairs works were scheduled to commence a bat survey was conducted to investigate if bats were still present. A number of bats were found to be still occupying the bridge so it was necessary to devise a system to allow the bats to leave the structure at dusk but to prevent them from regaining entry. A heavy duty tarpaulin was hung on both faces of the bridge that could be easily lowered to water level after the bats had emerged. That evening the tarpaulins were lowered to effectively exclude the bats from the structure. All crevices marked for retention were stuffed tightly with bubble-wrap to prevent grout entering. A wooden platform was erected running under the length of the arch and was covered with heavy plastic in order to prevent any building materials falling into the water course. On completion of the works the bubble wrap was removed to allow bats re-access the site.
